# **Engineers Without Borders- Peru Team- Report**

## **The Mission**

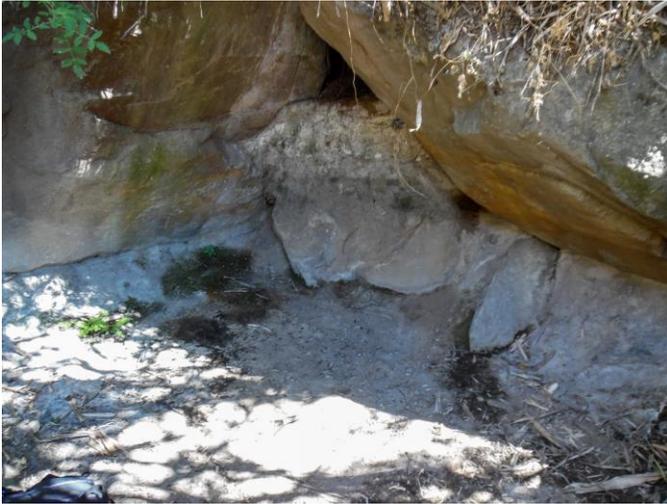
The first source we looked at was the Pitajaya Alta source. The problem with this source could not be determined at first because it was sealed off with concrete to protect it from falling rocks. To examine it we had to break it down completely. As we tore down the concrete we saw that tree roots were growing into the structure and that it wasn't built well by the previous mason so not all of the water was going directly into the system. To solve this we built stronger and neater concrete wall into the sides of the source capture and placed a lid that could later be taken off so that the community members can look inside to fix possible issues.

The Pitajaya Alta source before repair. You can see wet surfaces where we were losing water.

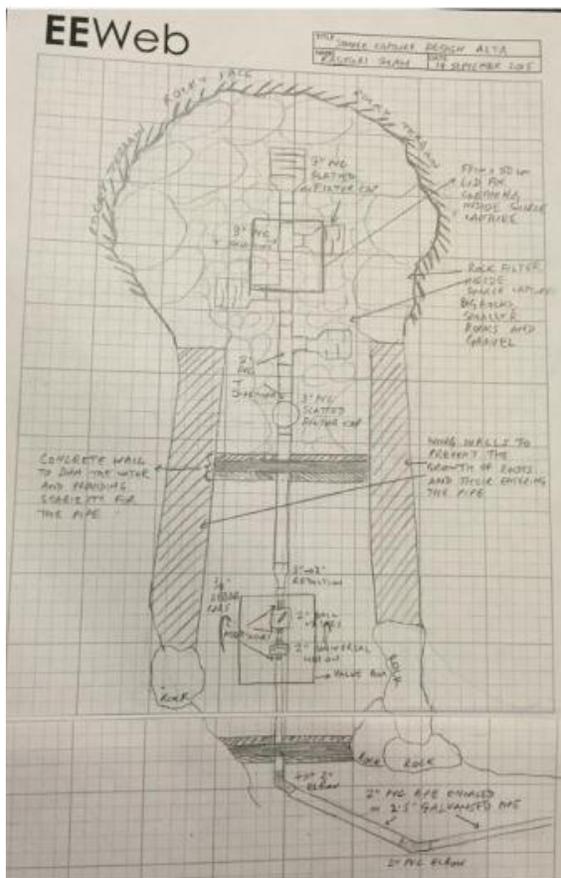
Plans for rebuilding the source capture for Pitajaya Alta.

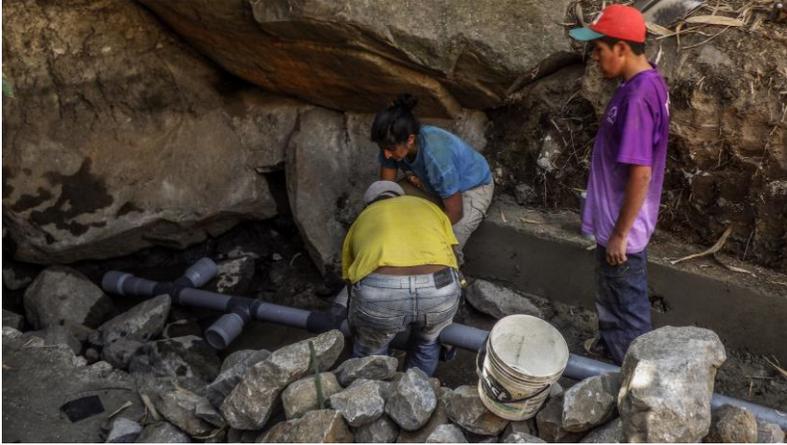
The team working on the Pitajaya Alta source. Notice the concrete walls on the sides for stronger structure.

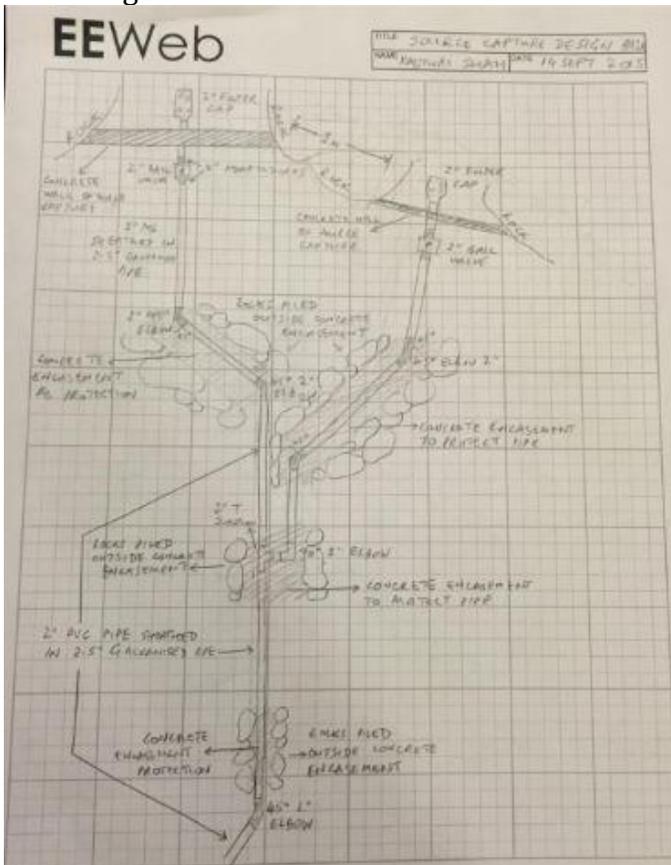
The second source that we looked at was the source in La Pitajaya Baja. The source capture itself was fine but we saw that there was water coming out nearby. We concluded that the ground water had slightly diverted and now some was coming out slightly further downhill. To fix this issue we simply expanded the source capture to catch the second stream of water and fed it to the system. After the source capture problems were fixed we replace the spring box in the Pitajaya Alta system and reinforced some galvanized tubing in the Pitajaya Baja system.

Plans for the La Pitajaya Baja source capture expansion. The tubing on the left is part of the capture that we built last year. The tubing on the right is the additional capture that we added to the system.

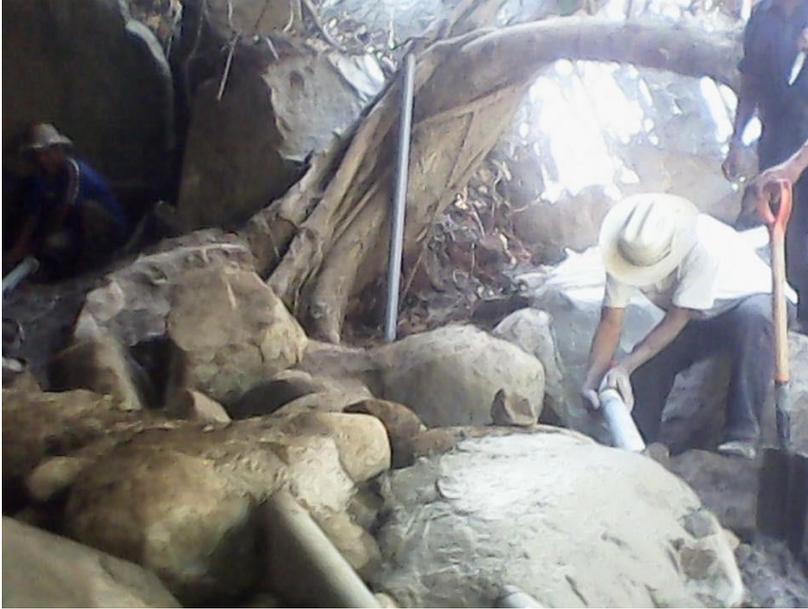
Construction of the Pitajaya Baja system. Previously built source capture on the far left. Additional capture on the right.
